RE: Progress report for October 2009 activities - Hecla Mining Company Apex Site
(EPA ID No. UT982589848, Docket No. RCRA-8-99-06)

SUBJECT: Progress Report No. 66 for period ending October 31, 2009; Pond 2 Final Closure - Apex Site, Washington County, Utah

TO: Paul Glader (Hecla Mining Company)
FROM: Doug Gibbs (Monster Engineering Inc.)
DATE: 10/19/09
SUBJECT: **Surface Monument Survey Data Review – Apex Site**

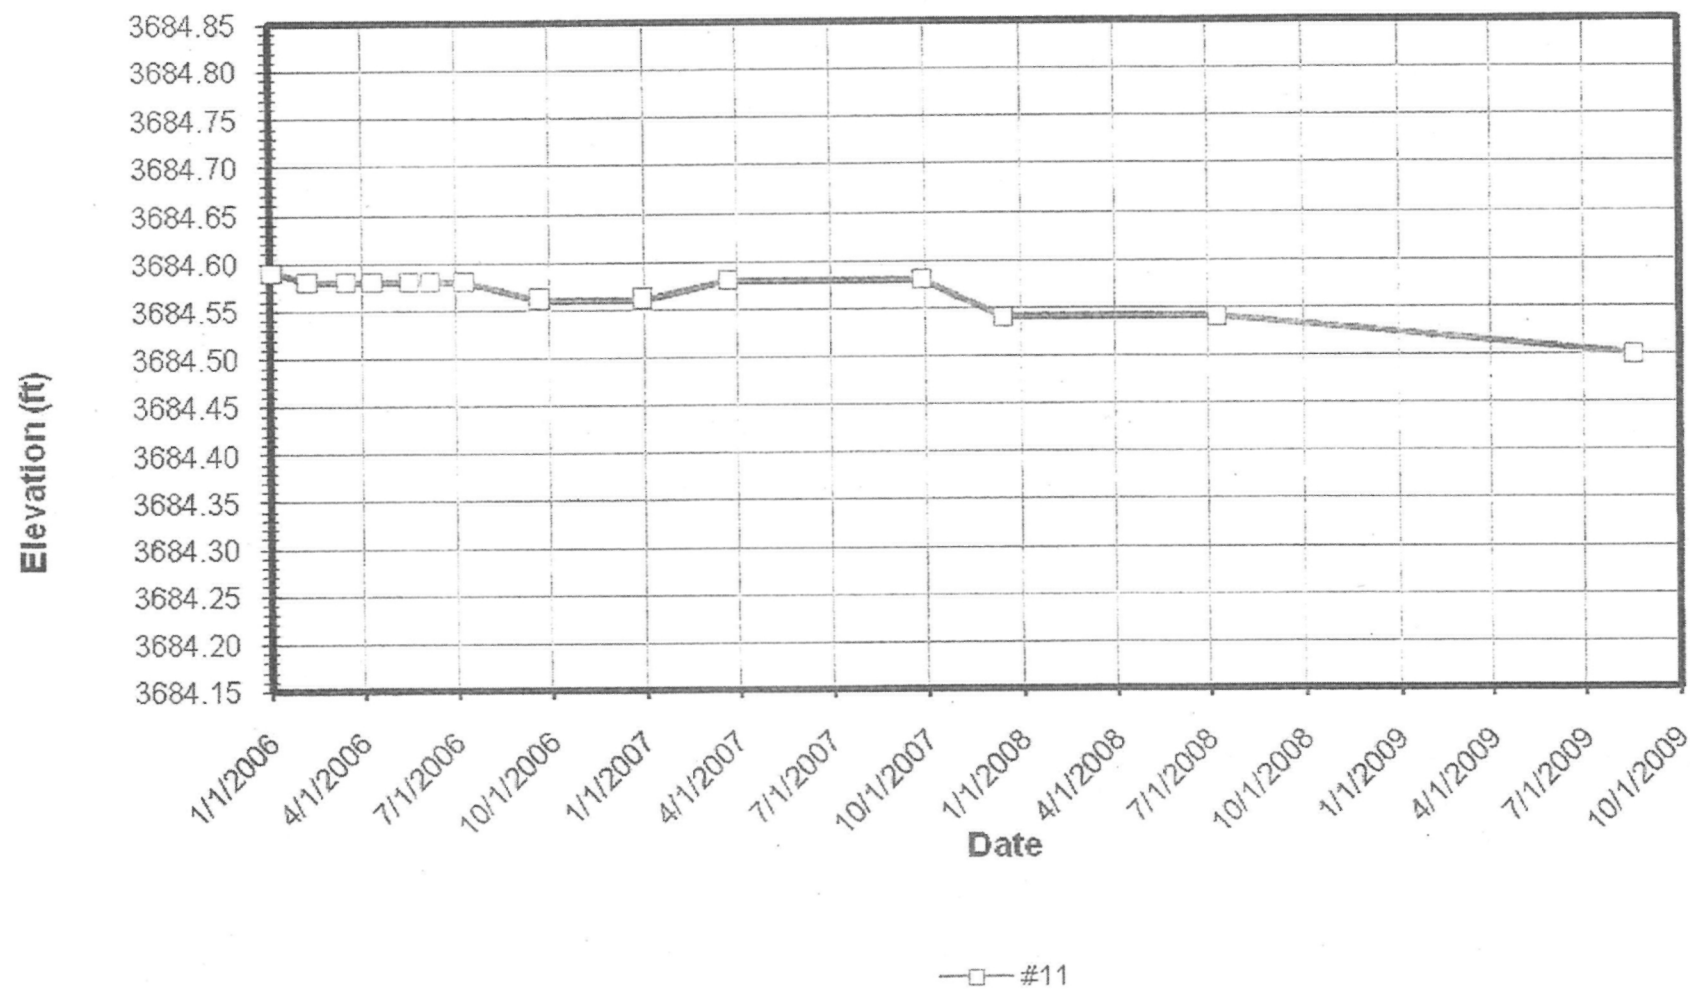
Apex Pond 2 - Settlement Monument Elevations

The settlement monitors were surveyed on August 17, 2009. No appreciable movement was noted. MEI prepared a Surface Monument Survey Data Review. Based on surface monitoring survey data collected from January 2006 through August 2009:

Based on data collected to date, MEI recommends that Hecla continue with their current plan and collect elevation data annually. Please contact me if you have any questions concerning this review.
